# Upper Slate River Watershed Plan Executive Summary

**Prepared For:**  
The Coal Creek Watershed Coalition  
Upper Slate River Steering Committee  
PO Box 39 Crested Butte, CO 81224  
[www.coalcreek.org](http://www.coalcreek.org)

**Prepared By:**  
Ashley Bembenek  
Alpine Environmental Consultants LLC

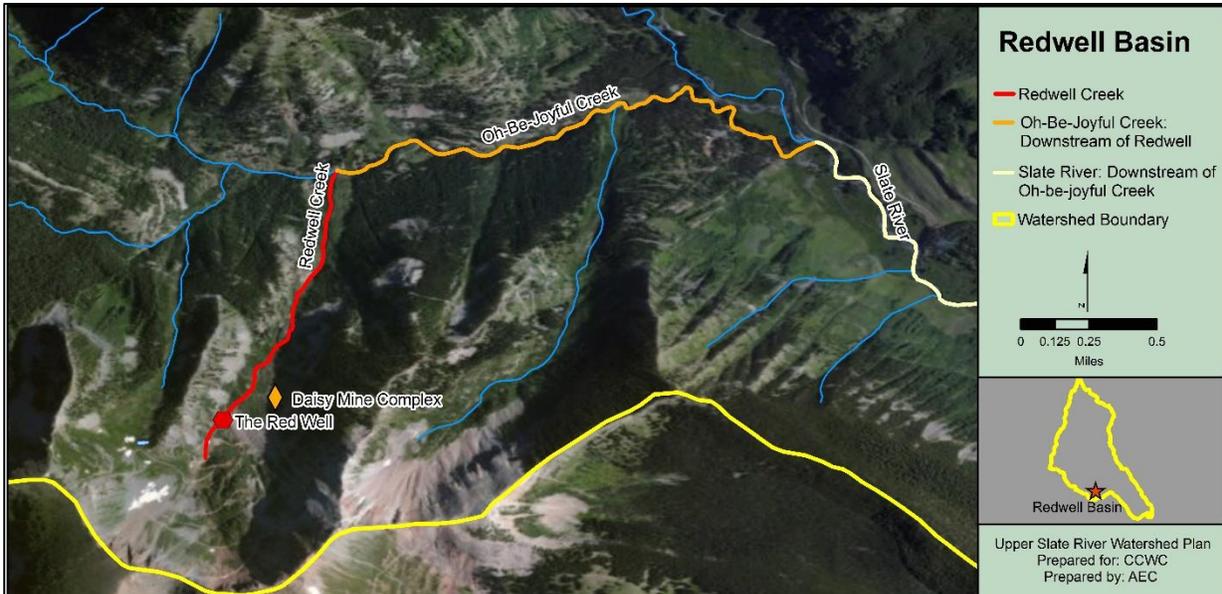
Metals that originate from historic abandoned mines and natural features pollute Redwell Creek. Redwell Creek, which has elevated concentrations of several metals, flows into Oh-B-Joyful Creek which is tributary to the Slate River. The effect of metals from Redwell Basin is apparent in Redwell Creek, Oh-Be-Joyful Creek and the Slate River.

The water quality standards assessment painted a clear picture. Metals that originate from historic abandoned mines and natural features impair water quality in Redwell Creek. Redwell Creek and the adjacent features accounted for seventy-five percent of the water quality exceedances. Redwell Creek delivers metals to Oh-Be-Joyful Creek and Oh-Be-Joyful Creek below Redwell Creek accounted for ten percent of the exceedances. The water in Oh-Be-Joyful Creek above Redwell Creek generally met all water quality criteria and accounted for less than one percent of the exceedances. Conservatively, Redwell Basin was the origin of eighty-five percent of the pollution in the Watershed. Although Oh-Be-Joyful Creek provides dilution, it is evident that metals that originate in Redwell Creek reach the Slate River. The Slate River below Oh-Be-Joyful Creek accounted for ten percent of the exceedances. The Slate River above Oh-Be-Joyful Creek typically met water quality criteria; only two percent of the evaluations exceeded applicable standards. Water quality exceedances in tributaries to the Slate River, including poverty Gulch, accounted for just over one percent of the exceedances.

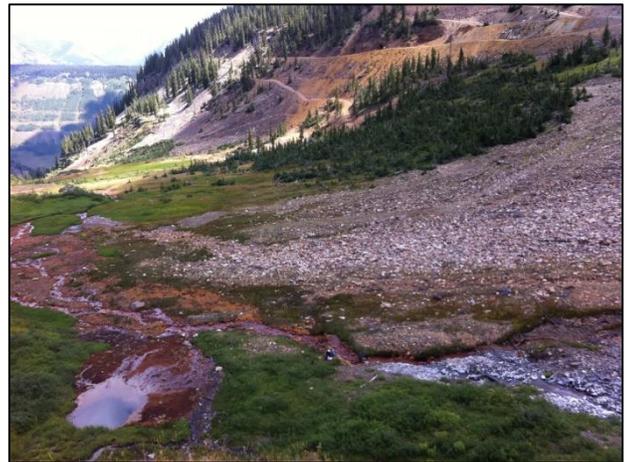
A view of Redwell Basin. The orange slopes on the upper right of the photo are a part of the Daisy Mine, the drainage tunnel is located in the lower portion of the mine waste. In the lower right of the photo, flow from the Drill Hole enters Redwell Creek. The Redwell is in the lower left of the photo. Photo Credit: Nicki DeVanni (2011).

In the early 1970s, many holes were drilled to characterize the molybdenum deposit beneath Mount Emmons. In Redwell Basin a drill hole, located in the upper portion of the basin, was improperly abandoned. The Drill Hole penetrates the molybdenum deposit and allows water to flow under pressure to the surface. It delivers poor-quality groundwater to Redwell Creek. At the Drill Hole, metal concentrations increased dramatically over upstream locations in Redwell Creek.

The Redwell is the naturally-occurring namesake of Redwell Basin. The Red Well is approximately 2,800 years old. The age was established by analyzing an iron oxide, called ferricrete, collected from the edge of the Red Well. The age indicates the feature is natural, not man-made. Metal concentrations measured at the Red Well are elevated, and occur in ratios similar to those found at the Drill Hole, but in lower concentrations. This suggests the two features share source waters, groundwater associated with the molybdenum deposit and the adjacent mineralized fracture network, but additional dilution occurs at the Red Well. Small seeps and wetland vegetation up-gradient of the Red Well indicate the area is saturated regularly. Given the hydrology of wetlands, some dilution with surface or groundwater is likely at the Red Well.
